SURVEY AND INVESTIGATION OF PERFORMANCE OF SUPERSTRUCTURE OF LONG SPAN BRIDGES IN CHINA

Mingfang Yang, Jinxin Gong*

Faculty of Infrastructure Engineering, Dalian University of Technology, Dalian 116024, Liaoning, China

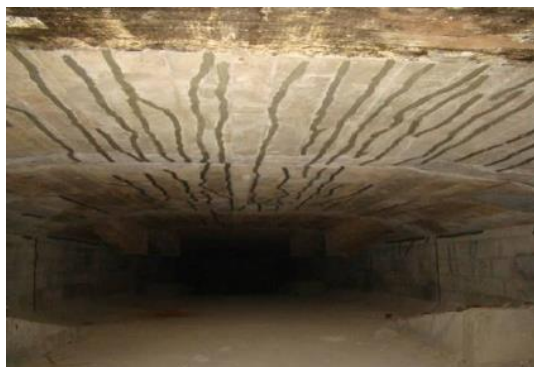
Figure 2 Longitudinal cracks in top slab

The cracks, including longitudinal and transverse cracks, in the top and bottom slab of prestressed box girders are more common (Wang *et al.* 2008; Yuan 2006). Both the longitudinal and transverse cracks reflect the insufficient capability of crack resistance of each slab. Longitudinal cracks in the top slab and transverse cracks in the bottom slab are shown in figures 2 and 3 respectively.

The causes responsible for the formation of longitudinal cracks include:

- insufficient transverse effective prestress or excessive transverse prestressing loss,
- deviation of transverse prestressing tendons,
- insufficient consideration for the radial force resulting from the longitudinal prestress,
- thermal stress caused by cement hydration during construction.

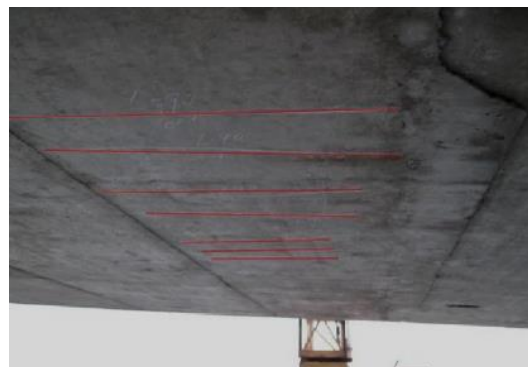
Figure 3 Transverse cracks in bottom slab

The causes resulting in transverse crack include:

- insufficient longitudinal effective prestress or excessive longitudinal prestressing loss,
- underestimation of shrinkage and creep by theoretical prediction,
- insufficient consideration on shear lag effect, leading to a higher section stress peak than the average (Qiao 2011).
